NOTICE OF VIOLATION FOR SANITARY SEWER OVERFLOWS, CALIFORNIA DEPARTMENT OF CORRECTIONS–MULE CREEK STATE PRISON, AMADOR COUNTY

INSPECTION REPORT

DISCHARGER: CALIFORNIA DEPARTMENT OF CORRECTIONS, MULE CREEK
STATE PRISON

INSPECTION DATE: 11 August 2020

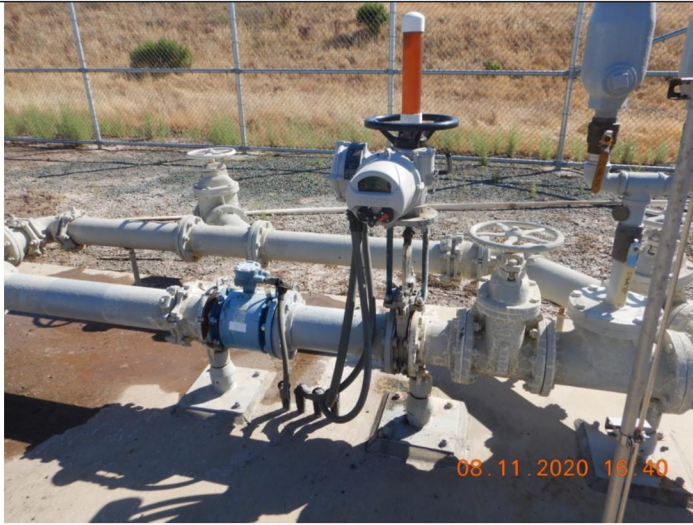
- The spill occurred at the lift station just downhill and southwest of the MCIC. The logic controller for the lift station had faulted, which had automatically closed a knife gate that controls the output flow from the lift station. With the gate closed, sewage slowly backed up in the vault, eventually overflowing and running down the hill towards Mule Creek.

Photo 1. Knife gate that was closed by SCADA system failure, causing the backup in the lift station vault and eventual overflow. Lift station is located just southwest of Mule Creek Infill Complex.

1. No later than **15 October 2020**, submit a statement, certified by the Chief Plant Operator, that the SCADA system and MCIC lift station has been inspected and repairs/corrections have been made to ensure an issue similar to what caused the spill on 10 August 2020 will not occur in the future.
2. No later than **15 October 2020**, submit the current Sanitary Sewer Maintenance Plan for the facility.

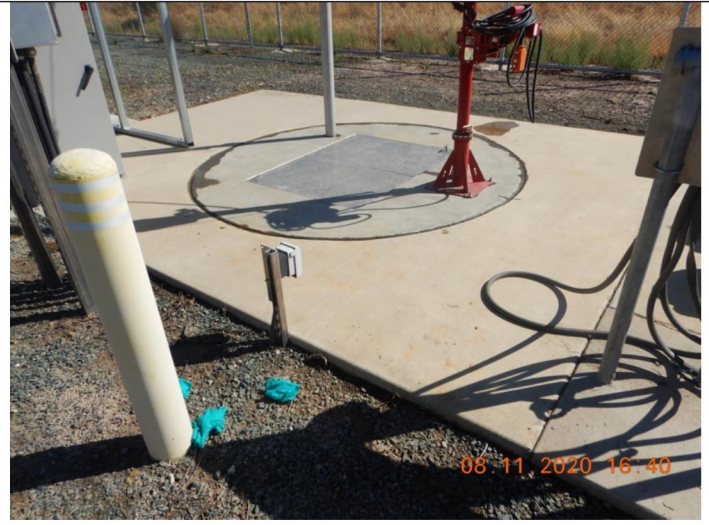
Photo 2. Vault of lift station where overflow occurred. Knife gate in photo 1 is approximately 20 feet to the right. Vault is approximately 500 feet from the creek bed of Mule Creek.

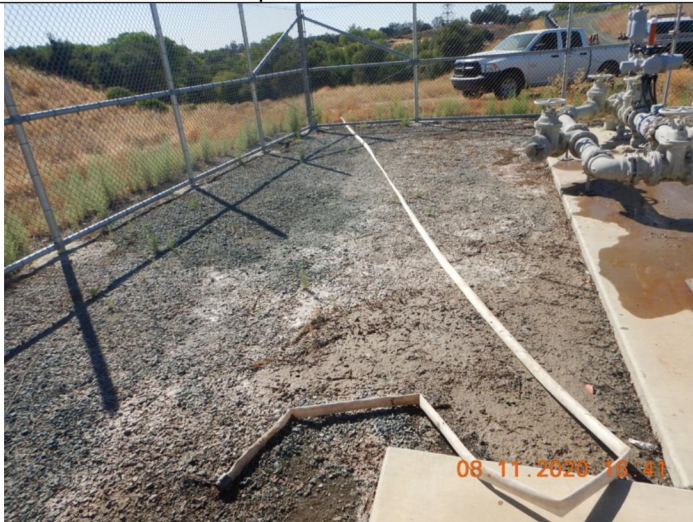
Photo 3. Hose running from small diversion downhill from the lift station back to the lift station vault. Hose was used to pump back collected sewage in bermed area (see photo 4).

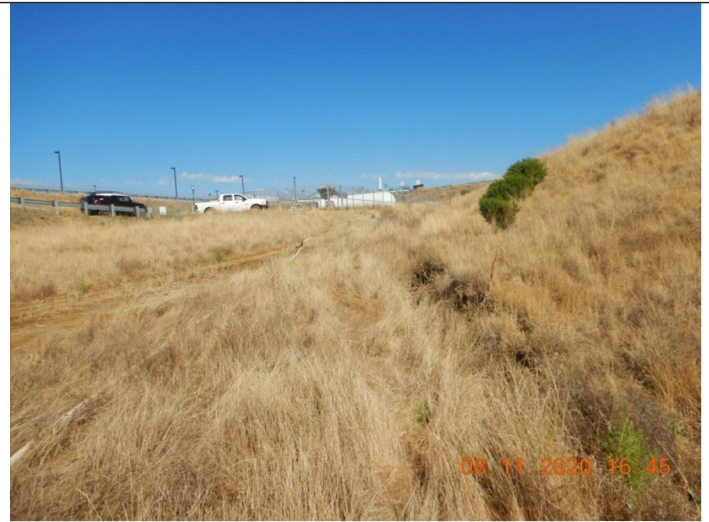
Photo 4. View from bermed area looking east towards lift station approximately 300 feet away. Hose on left leading from trash pump to vault.

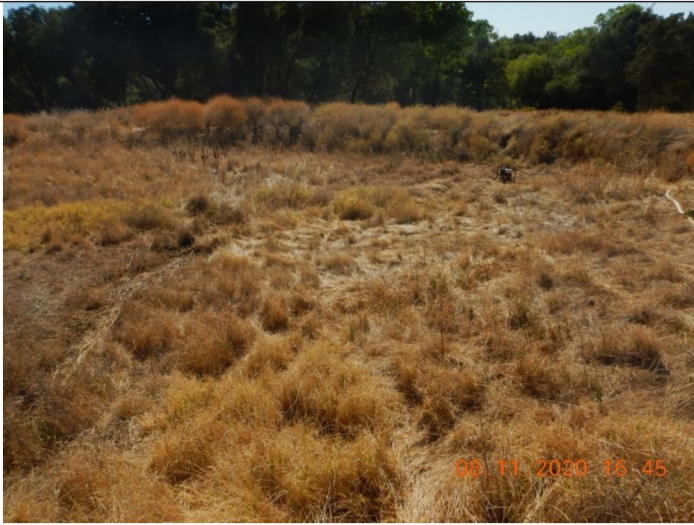
Photo 5. View of bermed area and trash. Bermed area was constructed in case of overflow from lift station. CDCR staff stated that there is a slide gate installed in the berm, but the slide gate was open during the discharge so only a small portion of the total volume of the bermed area was able to hold back sewage.

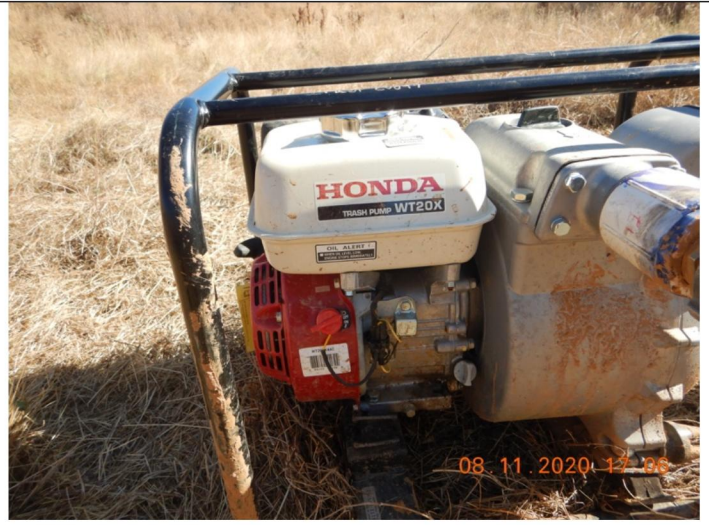
Photo 6. Honda WT20X trash pump which was used to pump sewage contained by bermed area back to lift station vault.

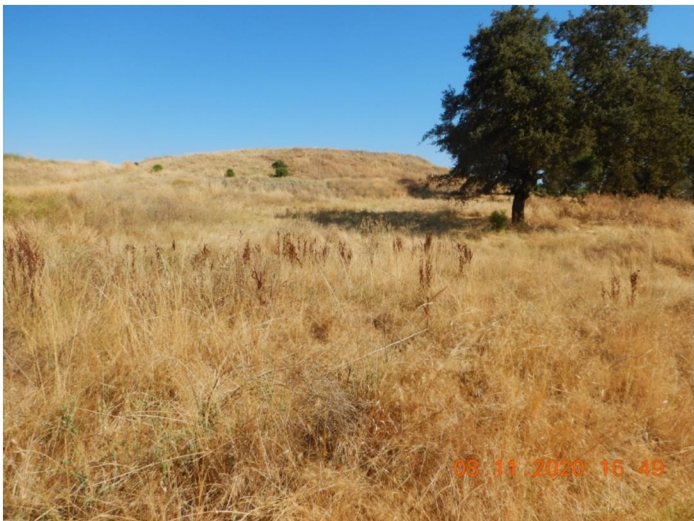
Photo 7. Picture taken from the access road, approximately 400 feet west of lift station. Mule Creek creek bed is approximately 100 feet further west.

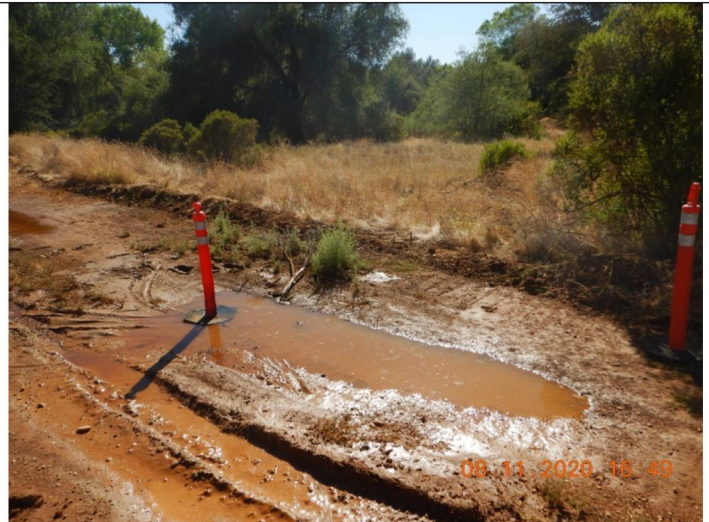
Photo 8. Pooled water on access road from spill, approximately 100 feet from creek.

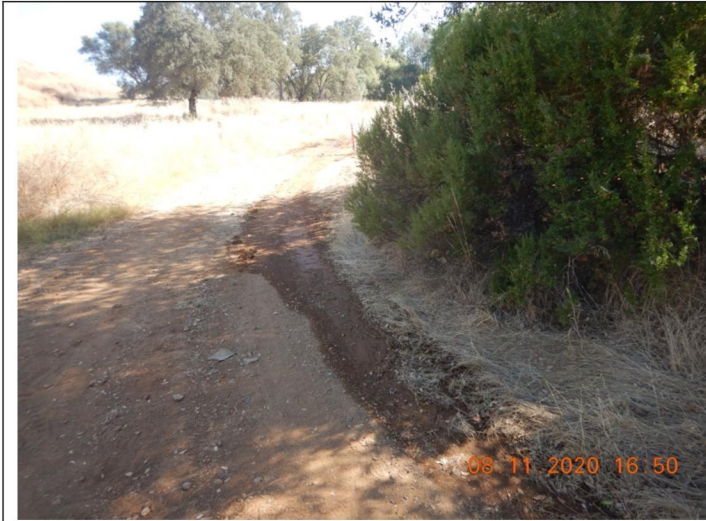
Photo 9. Damp soil going down the road towards creek, facing approximately east.

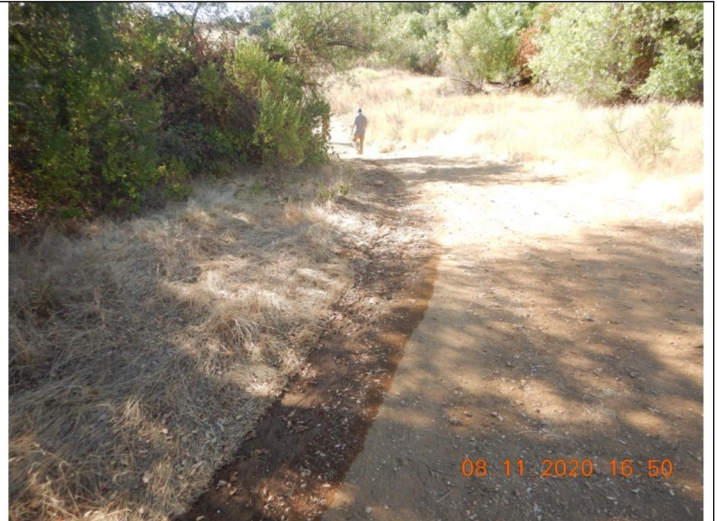
Photo 10. Damp soil going down the road towards creek, facing approximately west.

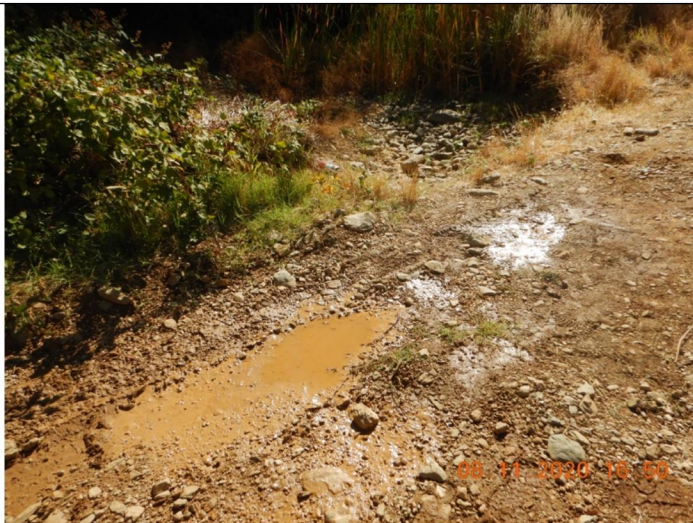
Photo 11. Small puddle of water on road of creek crossing. Creek bed in background. This is the location where the overland flow of sewage entered the creek bed.

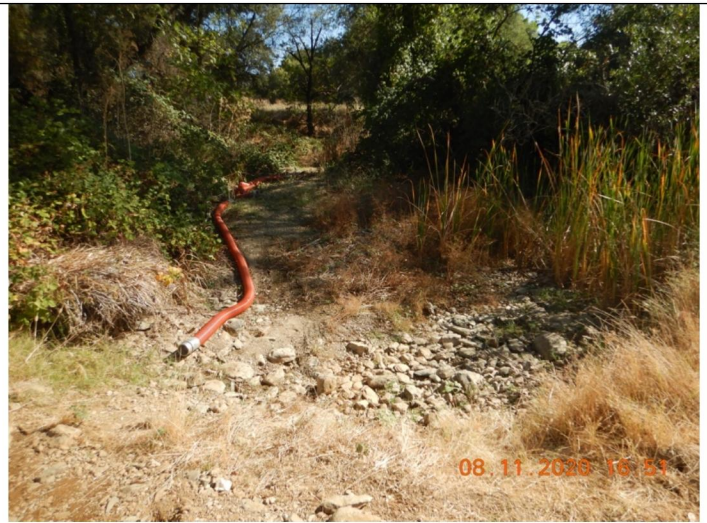
Photo 12. Creek bed of Mule Creek from the stream crossing nearest to the lift station. Lift station is approximately 500 feet to the left of this picture, east of the creek. Hoses were left from vacuum truck after recovery effort.

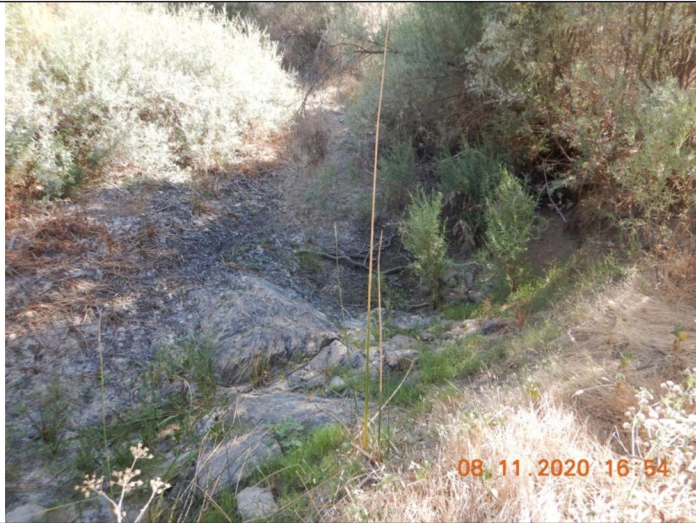
Photo 13. Creek bed of Mule Creek approximately 200 feet downstream from crossing in Photo 11. Damp soil observed.

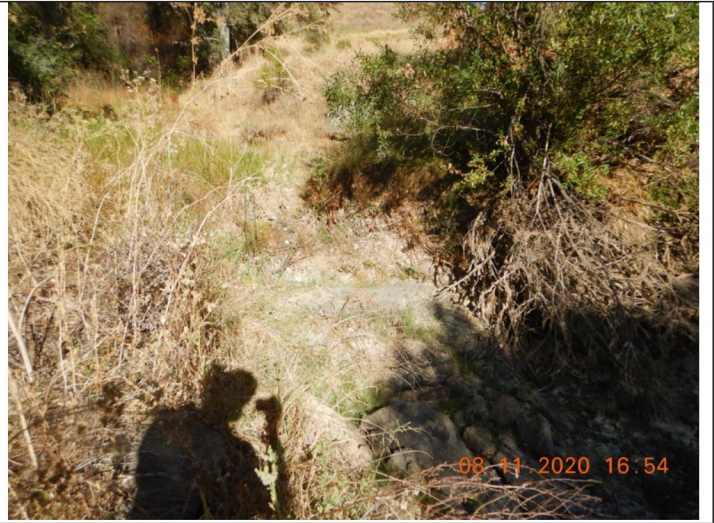
Photo 14. Creek bed of Mule Creek approximately 150 feet downstream from crossing in Photo 11. Damp soil observed.

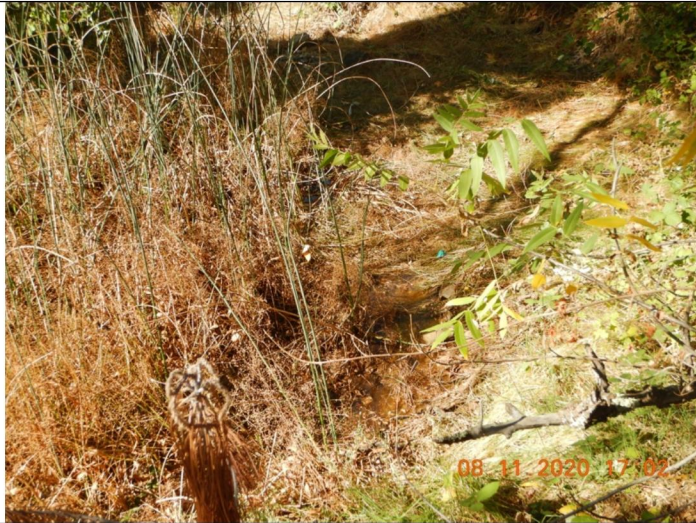
Photo 15. Creek bed of Mule Creek approximately 250 feet downstream from crossing in Photo 11. Small amount of ponded water in depressions.

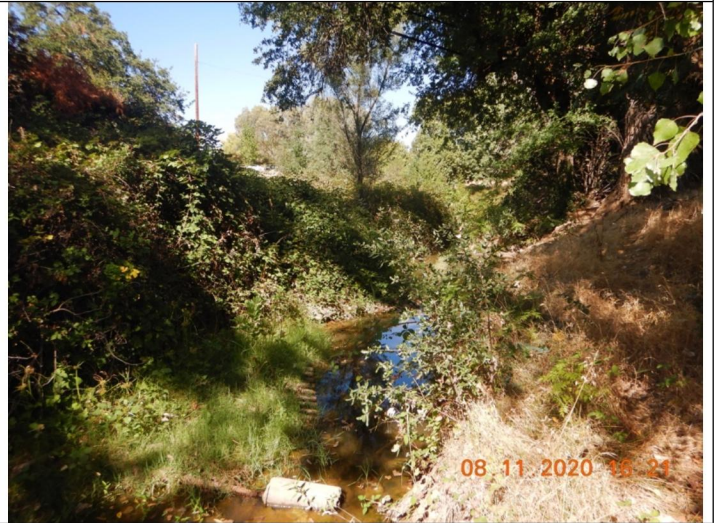
Bridge at Highway 104: Board staff observed a significant amount of water just upstream of (on CDCR property) and under the bridge where Mule Creek passes under Highway 104 (Photos 16, 17, 18, and 19). A small amount of flow was observed in the creek at this location, less than 5 gallons per minute. Water appeared slightly opaque and had a mild stagnant odor (Photo 19). Algae clumps were also observed in the water. Thick green vegetation in the area suggests that the area is wet frequently even through the dry season. The stormwater outfall is located just upstream of the bridge, but was obstructed by thick vegetation. It was unclear if there was a discharge from the stormwater system at the time of the inspection. Just downstream of the bridge was a deeper ponded area of water of a similar quality (Photo 20). Rags including what appeared to be partially broken down toilet paper and sanitary wipes were observed in the brush along the creek just downstream of the bridge (Photo 22). CDCR staff stated they thought it was more likely irrigation runoff from the land application areas than sewage from the spill.

Photo 16. Looking up Mule Creek from the Highway 104 bridge. Location is approximately 4000 feet downstream from the crossing shown in Photo 11. Significant water was present in creek. Very small amount of flow was observed.

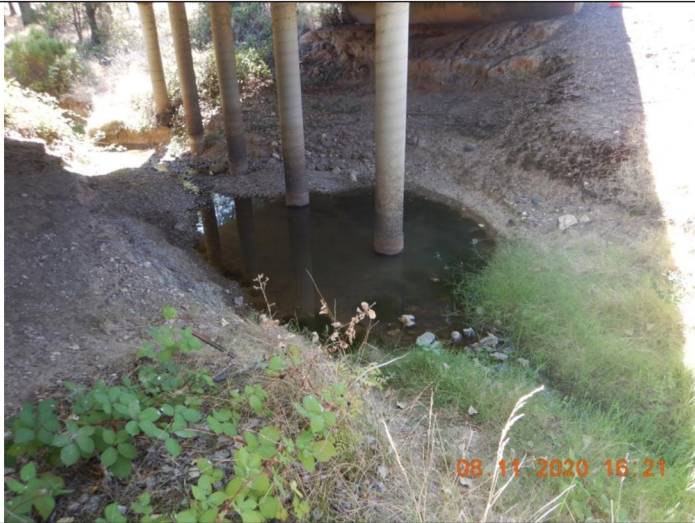
Photo 17. Ponded water under bridge where Mule Creek passes under Highway 104.

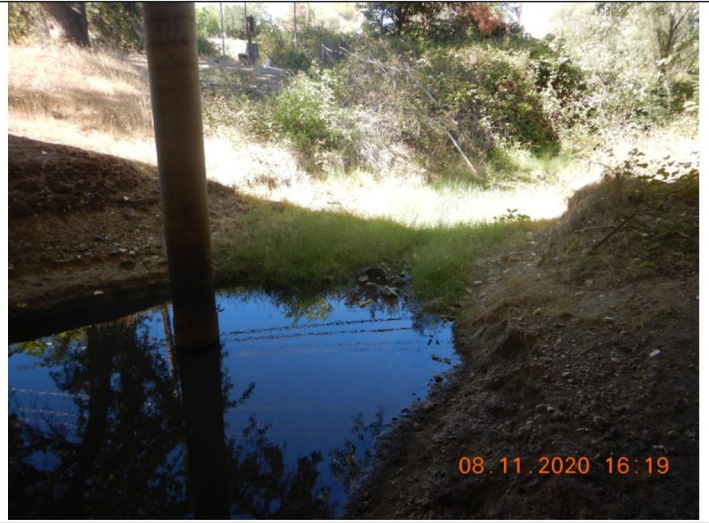
Photo 18. Ponded water under bridge where Mule Creek passes under Highway 104. Mild stagnant water odor observed.

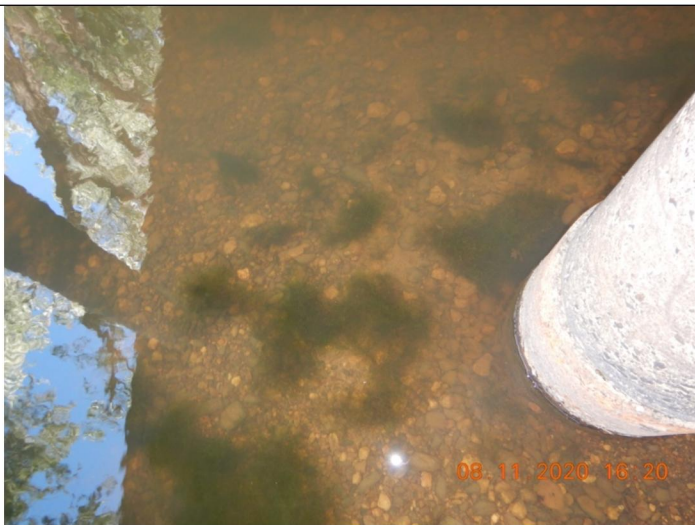
Photo 19. Close up of ponded water under bridge where Mule Creek passes under Highway 104. Water appeared slightly opaque and had large clumps of green algae looking material.

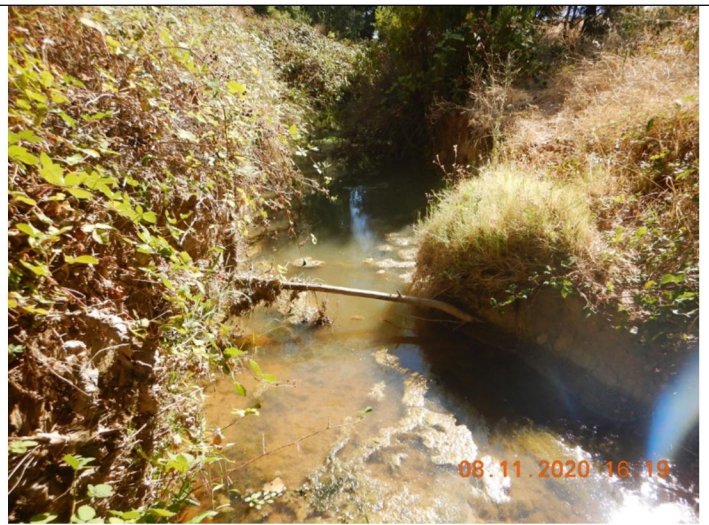
Photo 20. Looking downstream from under the bridge. Small amount of flow moving downstream. Water appeared slightly opaque and had large clumps of algae. Some rags observed (see Photo 22).

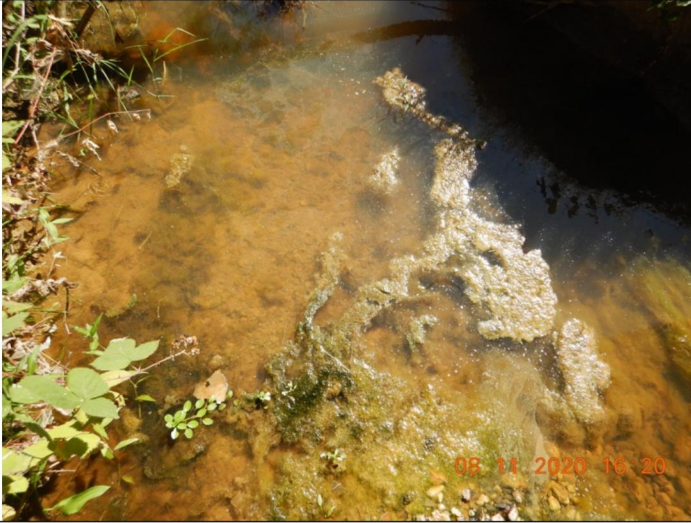
Photo 21. Close up of ponded just downstream of bridge where Mule Creek passes under Highway 104.

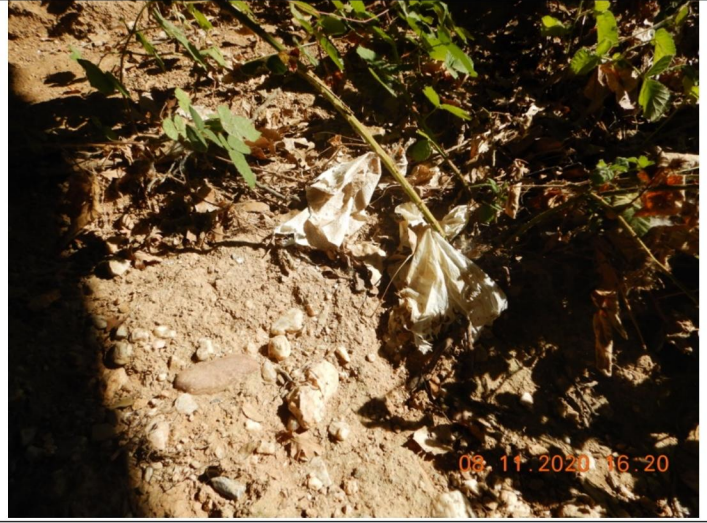
Photo 22. Rags observed in brush next to creek. Appears to be toilet paper and a sanitary wipe.
